HISTORICAL SHORELINE CHANGE OF THAP SAKAE COAST, PRACHUAP KHIRI KAN, THAILAND

Abstract—Coastal erosion is a critical problem in Thailand significantly affecting the coastal development and economy of the country. This paper presents the situation of shoreline change along the Thap Sakae coast, which is one of the highest potential areas for Thailand's coastal development. To evaluate the coastal erosion situation of the study area, ten shoreline positions were extracted from the aerial photographs and satellite images taken between 1966 and 2017 using the Geographic Information System (ArcGIS). The rates of shoreline change were analyzed by the Digital Shoreline Analysis System (DSAS). Additionally, field surveys were carried out in 2018 to observe the current coastal environment. Based on the results from shoreline analyzes, the long-term (1966-2003) and short-term (2003-2017) average rates of shoreline change along the Thap Sakae coast were -0.14 and 0.3 m/y, respectively. As the average rate of shoreline change was less than ± 1 m/y, the Thap Sakae coast seemed to be a stable coastal area. However, local coastal erosion was found during the past 15 years due to land development

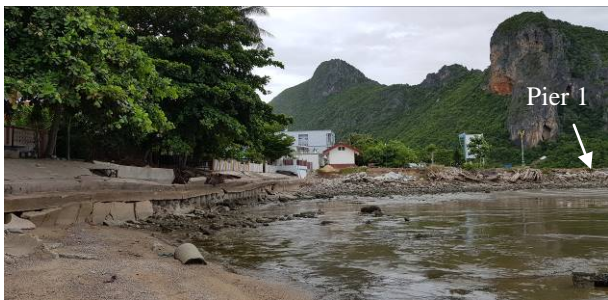
Fig. 5. Failure of shoreline protection at Ban Khlong Wan between transect 3 and 5.

From 1966 to 1976, the shoreline near the mouth of Khlong Wan retreated with the distance of about 20 m. After the construction of concrete pier (Pier 1 in Fig. 3) in 1996, it was found that shoreline between the river mouth and Pier 1 migrated seaward of about 15 m in 2002. As a result of the construction of a new fishery pier (Pier 2) at Ban Khlong Wan in 2005, longshore sediment transported northward were trapped at the upcoast of Pier 2. Therefore, seawalls and series of offshore breakwater were constructed at downcoast of the Pier 2 in order to reduce the beach erosion affected by the pier. Based on a field survey in 2018, however, failure of those coastal protections was found on the southern coast of Pier 1 as shown in Fig. 5. Ban Wa Ko coast located on the south of Pier 2 has also faced shoreline retreat because Pier 2 has trapped the longshore sediment transporting southward. Consequently, the downcoast experienced more than 15 m of shoreline retreat. Field surveys data indicated that private seawalls constructed by landowner have successfully protected the horizon changes (Fig. 6), but the vertical erosion of the beach occurred in front of those seawalls as depicted in Fig. 6.

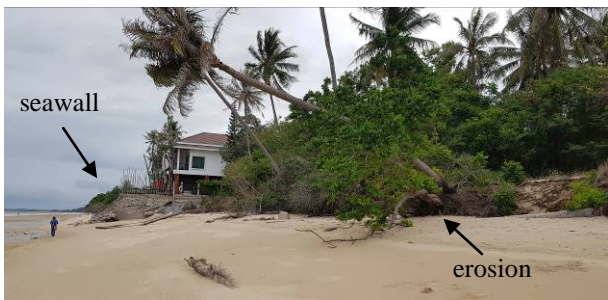
Fig. 6. Beach erosion along Ban Wa Ko.

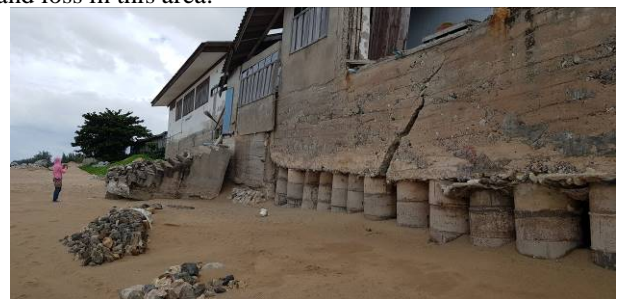
Fig. 7. Beach erosion and property damages along Ban Thung Pradu.

The 1.5 km coastline from Ban Nong Nam Khao to Ban Thung Pradu (transects 260 to 310) has experienced shoreline retreat of more than -20 m between 1966 and 1976. Then the coast seemed to be stable during the period 1976-1997 (21 years). However, the abrupt shoreline retreat of more than 10 m occurred between 1997 and 2017 (Fig. 2 (b)). Moreover, the beach in this area was narrow with the beach width of about 10 to 20 m. Even though the rate of shoreline change in this area may be low (less than -1 m/y) compared to other regions of the country, it has caused severe damages to local communities living along the coast as shown in Fig. 7. Figure 8 presents the construction of coastal protection structure (seawall) to mitigate the coastal land loss in this area.

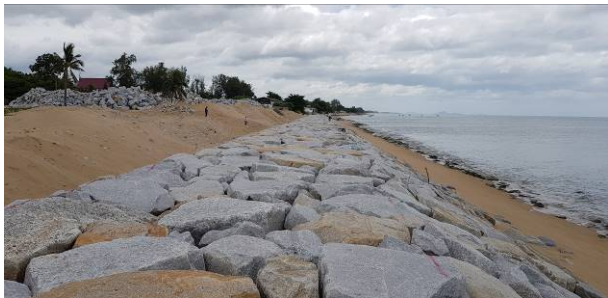
Fig. 8. The seawall was under construction along Ban Thung Pradu.
